# ENERGY STAR SHOWCASE: MONTGOMERY COUNTY GOVERNMENT

A CASE STUDY IN PROFITABLE POLLUTION PREVENTION

**C**ASE ..... HUNGERFORD OFFICE BUILDING

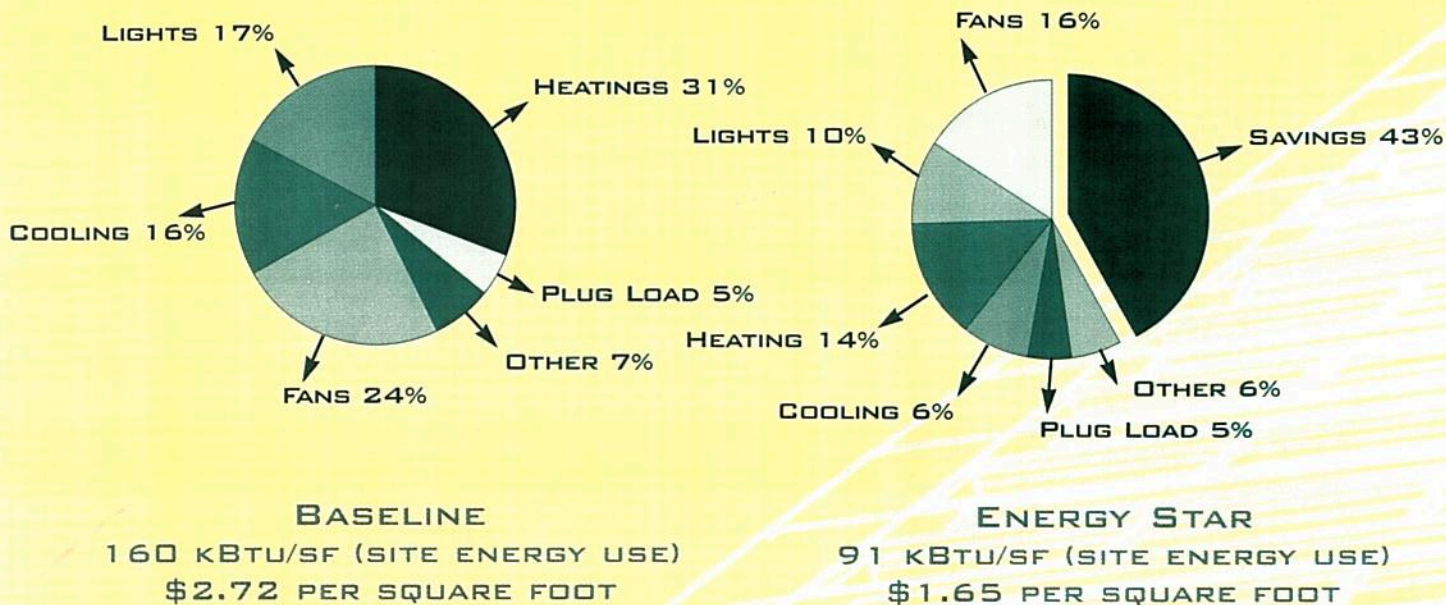
## PROFILE OF ENERGY END USES

\*PIE CHARTS ARE BASED ON SOURCE ENERGY USE, ASSUMING 2/3 LOSSES IN ELECTRICITY GENERATION.

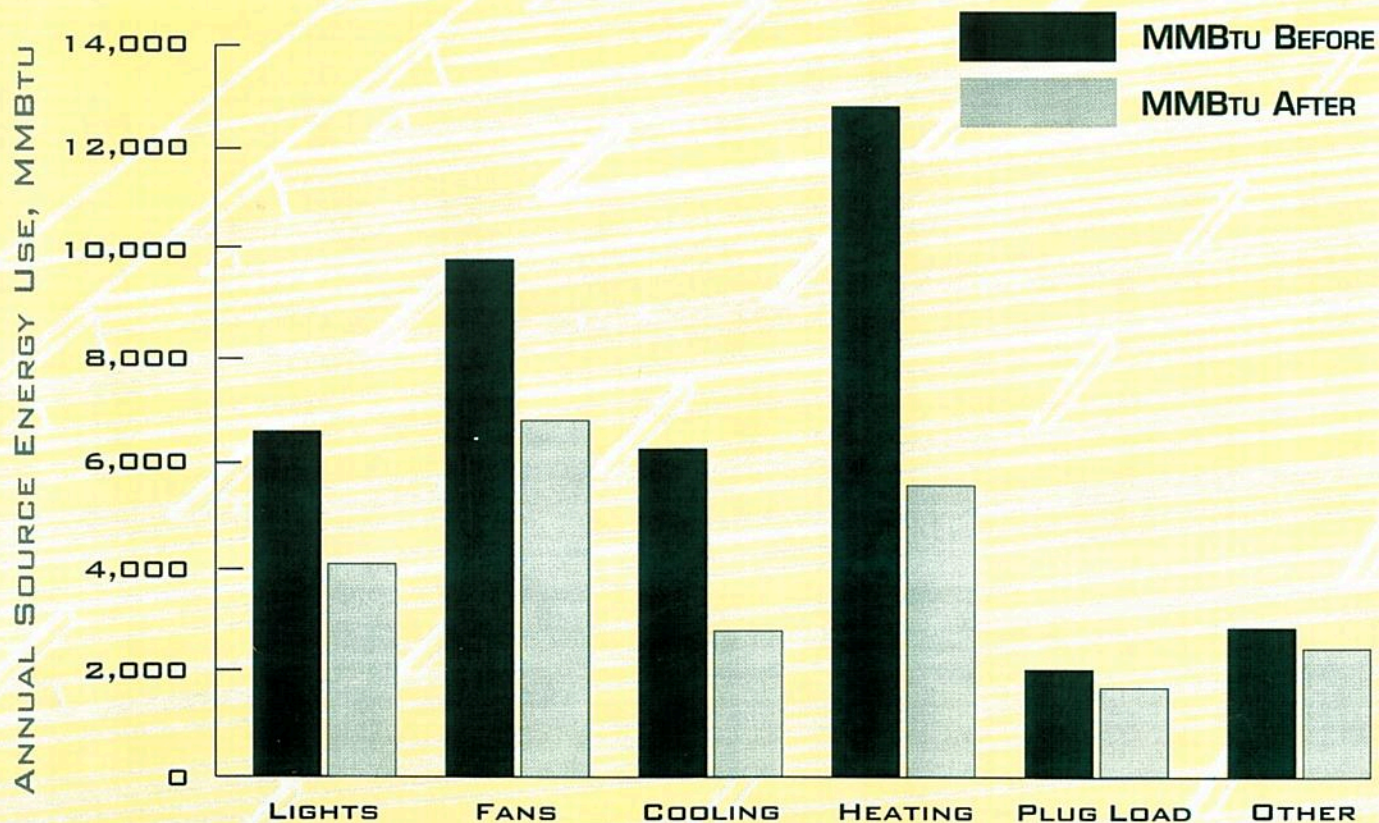
## ENERGY SAVINGS ARE PROFITABLE

39% ENERGY COST SAVINGS  
\$90,000 PER YEAR  
\$1.07 PER SQUARE FOOT  
PER YEAR
